# Manhole Inspection Summary

Manhole # S45G\_\_027MH

**Location** Address: **rear 2023 e pratt st**

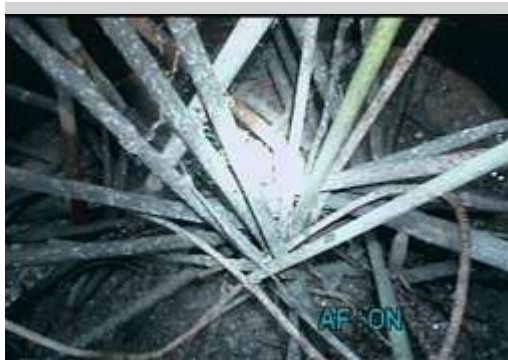
Defect 3

Condition: ☐ Sound ☐ Cracked ☐ Root Intrusion ☐ Deteriorated ☐ Leaks ☒ **Debris**

channel debris

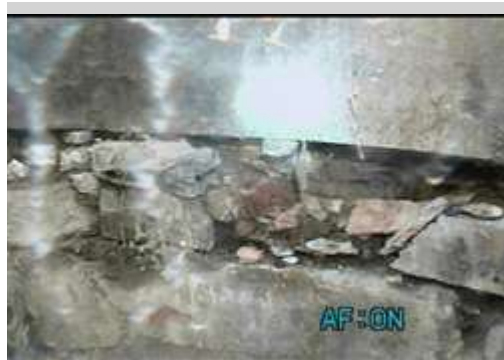
Defect 2

Condition: ☐ Sound ☒ **Cracked** ☐ Root Intrusion ☒ **Loose Brick** ☒ **Deteriorated**

chimney loose bricks, cracked and deteriorated, frame adj

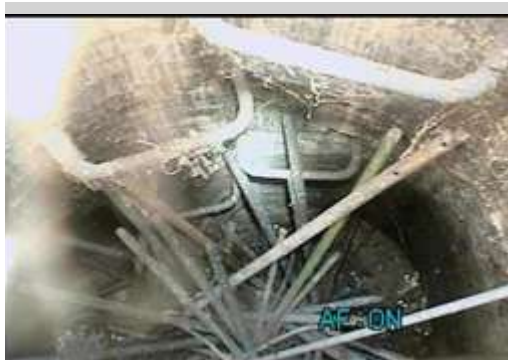
Defect 1

Condition: ☐ Sound ☐ Cracked ☐ Root Intrusion ☐ Loose Brick ☒ **Deteriorated**

**Steps** Count: **4** Missing: **0** ☒ **Corroded**

Barrell condition deteriorated and parged, corroded, steps

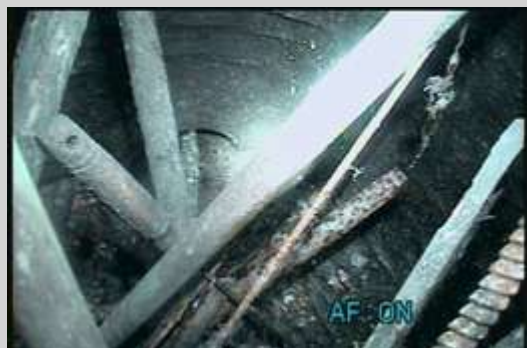
12 O'Clock Outflow

8 in. Circular Gravity Sewer  
Pipe Out @ 12 O'Clock

Deposits: ☐ None ☐ Mud ☐ Sludge ☒ **Debris** ☐ Grease

Silt Depth: **6** (in.) Deposits Extent: **Heavy**
